Written by Hans Summers Monday, 25 May 2009 03:02 -

30m QRSS beacon: QRV: even more changes

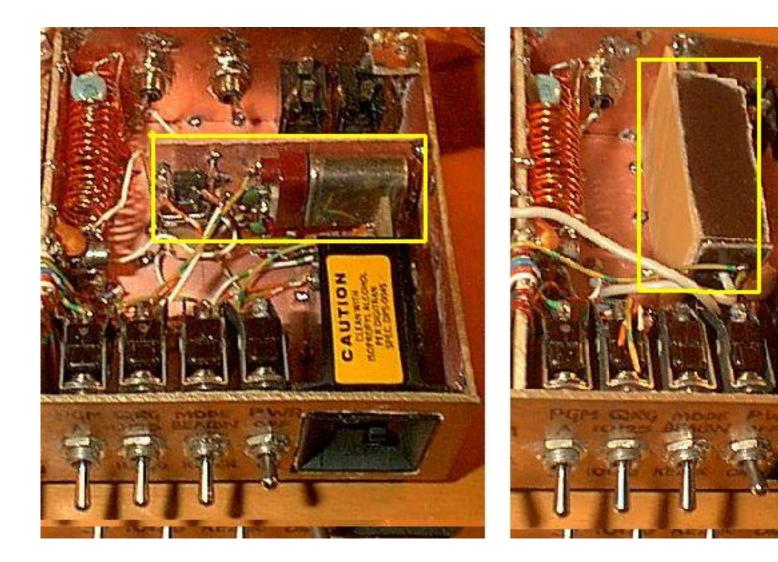
Yet one more attempt to remove the troublesome chirp and stabilise the frequency! Since the oscillator chip was right next to the output pi-network I decided to try moving it further away, and putting it in a screened box made from single-sided PCB stock. The picture shows the oscillator board, before and after. Screened cable takes the oscillator output to the pa, and brings in the frequency control voltage.

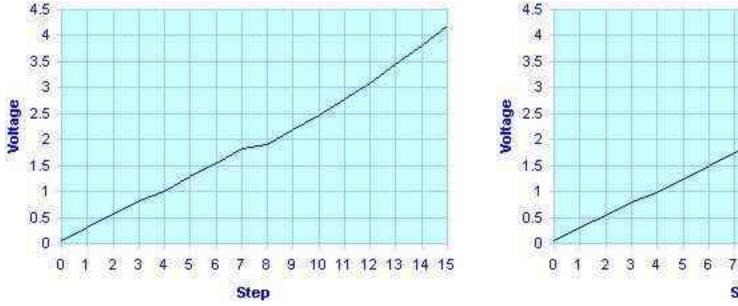
Next, I attempted to linearise the frequency shift (see the same-frequency 7'th and 8'th steps on the screenshots above). The lack of shift occurs when the shift changes from step 7 to 8. Therefore it is due to the 10K resistor in the resistor network being slightly off-value.

I ended up with 3 parallel resistors to the 10K resistor: values 220K, 470K and 560K. The combined value of the added parallel resistance is therefore 118K. The chart below shows the measured voltage before (left) and after (right) the corrective resistors were added. You can see that the problem with the curve at step 7 - 8 is gone. The line still isn't completely perfectly straight now I have measured it in detail, but it will be good enough to remove the observed discontinuity on the screenshots.

To correct the abnormality I experimented with several different value resistors in parallel with it (not being able to find easily a sufficiently high-valued preset potentiometer in the junk box). The
